Road Pavement Catalogue

The report below further explains and depicts the City's Roadway Rating System with basis points. The roadways are evaluated on a yearly basis and assigned basis points through a inspection process. The points are entered onto the Asphalt Pavement Rating Form and total condition rating is summarized. The results render a fair rating for upcoming bituminous overlay maintenance programs. The rating system utilizes a numerical assigned value of 0-5 and 0-10, whereas the higher numerical value indicates severe.

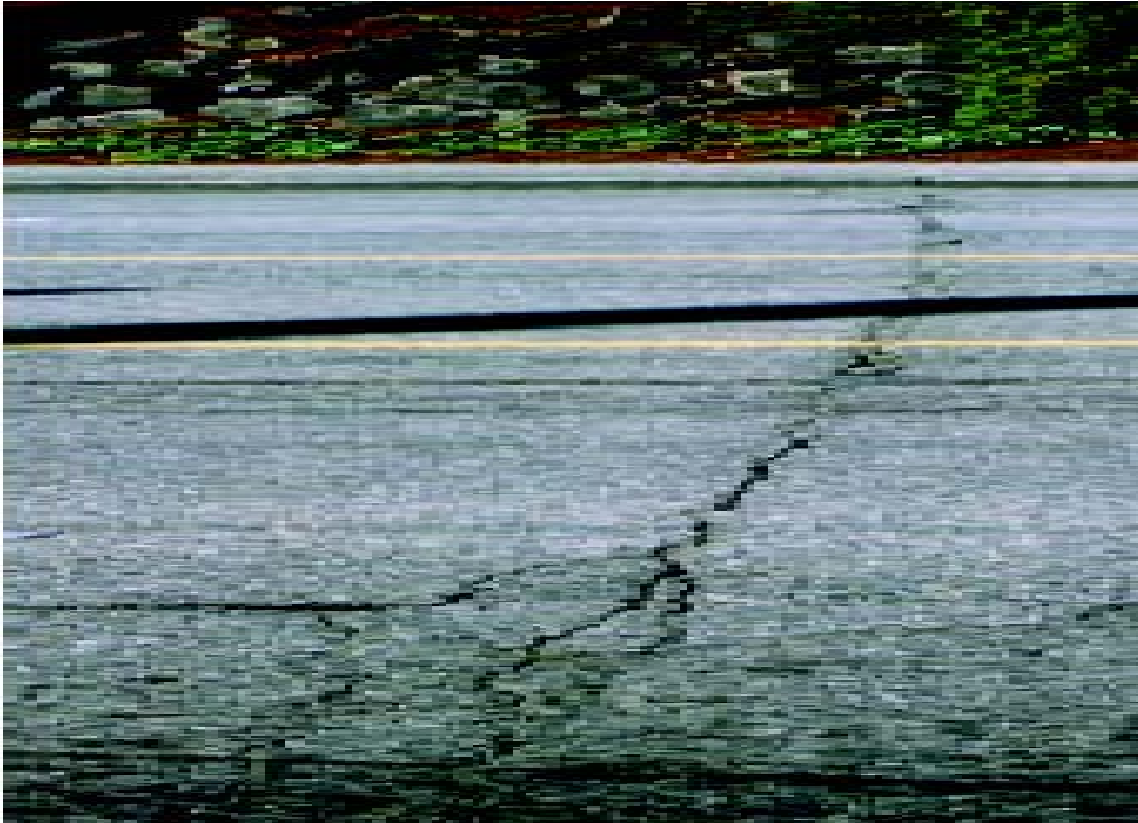
1. Transverse Cracking-Rating Factor 0-5

Transverse cracks run roughly perpendicular to the roadway centerline. These cracks are be caused by surface shrinkage due to low temperatures, hardening of the asphalt, or cracks in underlying pavement

layers. The cracks extend partially or fully across the roadway. The inspector will consider only those transverse cracks that are a minimum of two feet in length.

Low — The cracks have very little or no spalling along the edges and are less than $\frac{1}{4}$ -inch in width. If the cracks are sealed and the width of the crack prior to sealing is visible, they should be classified as Low Severity. (Good Prospect for Crack Sealing)

Medium — The cracks have little or no spalling but they are greater than $\frac{1}{4}$ -inch in width. There may be a few randomly spaced low severity connecting cracks near the main crack or at the corners of intersecting cracks. (Good Prospect for Crack Sealing)

High — Cracks are spalled and there may be several randomly spaced cracks near the main crack or at the corners of intersecting cracks. Pieces are visibly missing along the crack.

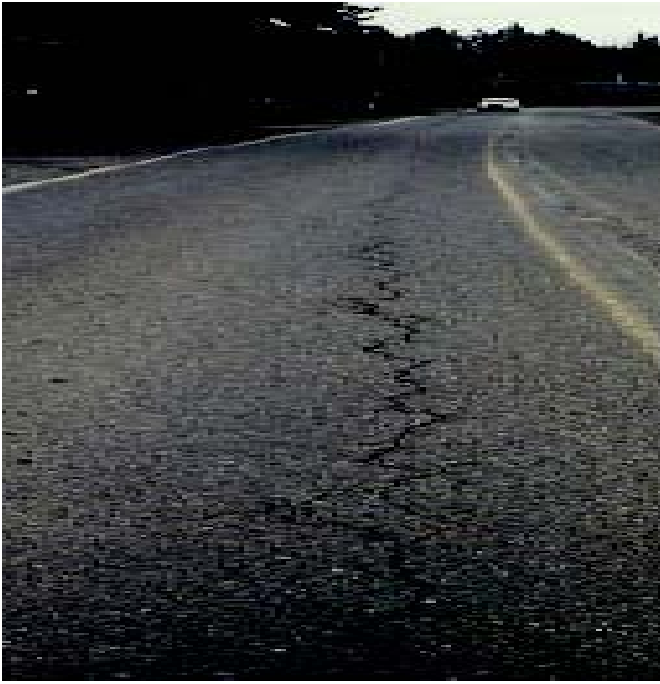
2A. Longitudinal Cracking-Rating Factor 0-5

Longitudinal cracks run roughly parallel to the roadway centerline. Longitudinal cracks associated with the beginning of alligator cracking are generally discontinuous, broken, and occur in the wheel path. However, any longitudinal crack that is clearly within the wheel path should be rated.

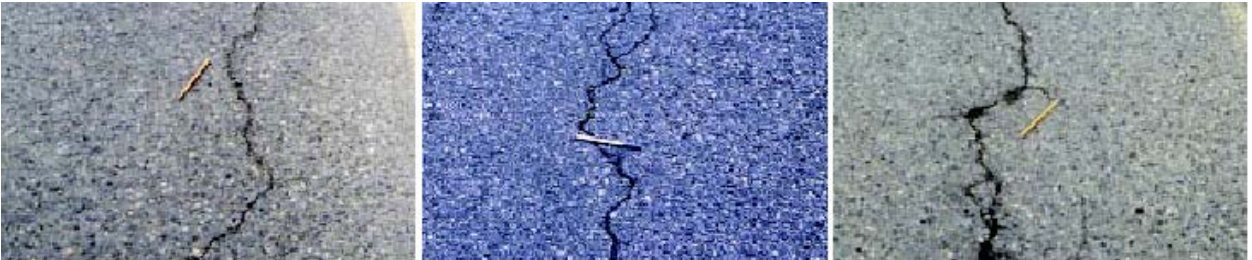
2b. Nonwheel Path Longitudinal Cracking

Nonwheel path longitudinal cracks run roughly parallel to the roadway centerline. They may be caused by a poorly constructed paving joint, a reflective crack caused by joints and cracks beneath the surface course, including joints and cracks near the edge of the pavement. These types of cracks are not load-associated. Low severity nonwheel path longitudinal cracking looks very similar to low severity alligator cracking; however, low severity alligator cracking always occurs in the wheel path and should be rated as alligator cracking. Please note that pending the longevity of a longitudinal crack it will develop into an alligator crack, and thus could increase the rating of an alligator crack significantly over a year.

Low — The cracks have very little or no spalling along the edges and are less than $\frac{1}{4}$ -inch in width. If the cracks are sealed and the width of the crack prior to sealing is visible, they should be classified as Low Severity. (Good Prospect for Crack Sealing)

Medium — The cracks have little or no spalling but they are greater than $\frac{1}{4}$ -inch in width. There may be a few randomly spaced low severity connecting cracks near the main crack or at the corners of intersecting cracks. (Good Prospect for Crack Sealing)

High — Cracks are spalled and there may be several randomly spaced cracks near the main crack or at the corners of intersecting cracks. Pieces are visibly missing along the crack. At some point, this longitudinal cracking becomes alligator cracking.

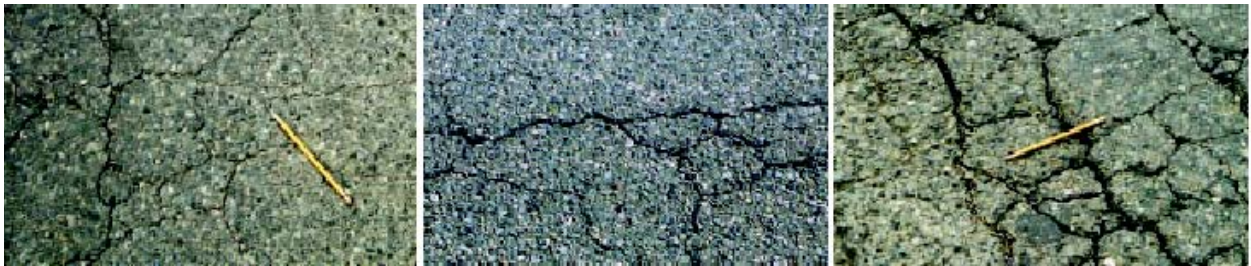
3. Alligator Cracking-Rating Factor 0-10

Alligator fatigue cracking is associated with loads and is usually limited to areas of repeated traffic loading. The cracks surface initially as a series of parallel longitudinal cracks within the wheel path that progress with time and masses to a more branched pattern that begins to interconnect. The stage at which several discontinuous longitudinal cracks begin to interconnect is defined as alligator cracking. Eventually the cracks interconnect sufficiently to form many pieces, resembling the pattern of an alligator. On two-lane roads, alligator cracking may form along the centerline rather than in the customary wheel paths. Usually, the patterns of the cracking, or the longitudinal cracks, are parallel to the roadway or direction of vehicle travel. Alligator cracking occasionally occurs in a pattern transverse to the roadway direction because of poor trench compaction, settlement, or frost action. Potholes and other occurrences of destroyed or missing pavement become prevalent as high severity alligator cracking occurs.

Low — Branched, longitudinal, discontinuous thin cracks are beginning to interconnect and form the typical alligator pattern with no spalling. (Good Prospect for Crack Sealing)

Medium — Cracking is completely interconnected and has fully developed an alligator pattern. Some spalling may appear at the edges of cracks. The cracks may be greater than 1/4-inch wide, but the pavement pieces are still in place.

High — The pattern of cracking is well developed. Spalling is very apparent at the crack. Individual pieces may be loosened and may rock under traffic. Pieces may be missing. Pumping of fine aggregates up through the cracks may be evident.

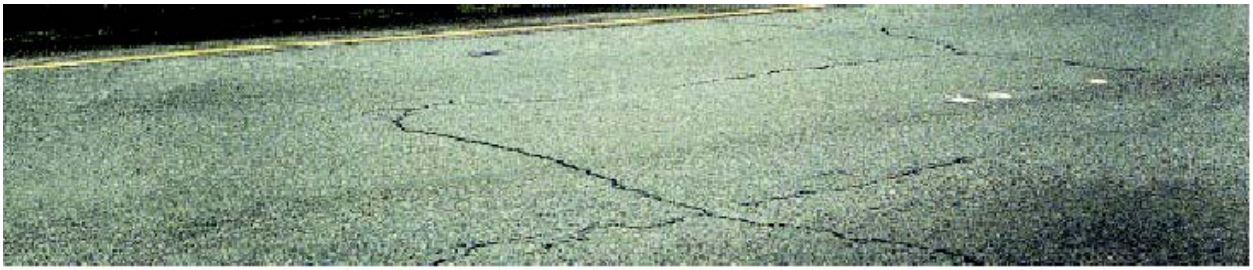
4. Shrinkage Cracks-Rating Factor 0-5

Shrinkage/Block cracks divide the pavement surface into nearly rectangular pieces with cracks that intersect at about 90 degrees. This type of distress differs from alligator cracking in that alligator cracks form smaller, irregular shaped pieces with sharp angles. In addition, alligator cracks are caused by repeated traffic loadings and are, therefore, generally located in traffic areas (i.e., the wheel paths). Block cracking is caused principally by shrinkage of the asphalt concrete and daily temperature cycling. It is not load-associated, although load can increase the severity of individual cracks. The occurrence of block cracking usually indicates that the asphalt has hardened significantly through aging. Block cracking normally occurs over a large portion of the pavement area including nontraffic areas. However, various fatigue related defects may occur in the same segment.

Severity: The severity of shrink/block cracking is defined by the average size of the blocks and the average width of the cracks that separate them.

Low — 9 × 9 feet or greater
RATING VALUE=1-2

Medium — 5 × 5 feet to 8 × 8 feet blocks
RATING VALUE=3

High — 4 × 4 feet blocks or less
RATING VALUE=4-5

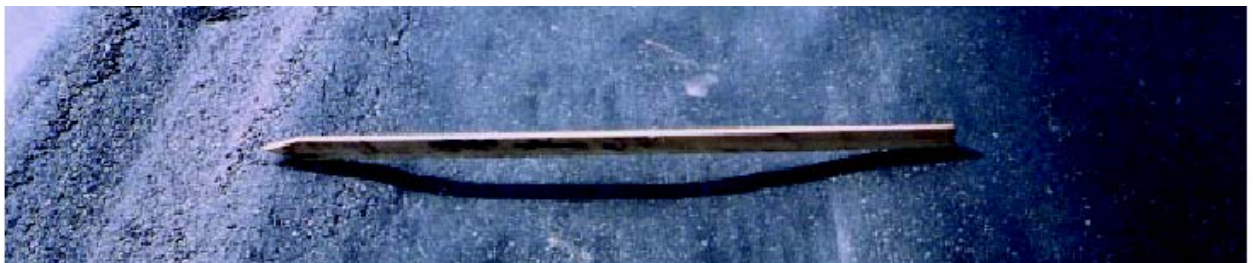
5. Rutting-Rating Factor 0-10

Rutting is a surface depression within the wheel path. Rutting results from a permanent deformation in any of the pavement layers or subgrades, usually caused by consolidation or lateral movement of the materials due to traffic loads. When the upper pavement layers are severely rutted, the pavement along the edges of the rutted area may be raised. Usually, the rutting occurs gradually across the wheel path, reaching a maximum depth in the center of the wheel path. Ruts are most obvious after rainfall when they are full of water. Wear is surface depression in the wheel path resulting from tire abrasion.

Severity: The average rut depth in the wheel path for the segment.

Low — 1/4-inch to 1/2-inch

Low-Medium — 1/2-inch to 3/4-inch

Medium-High — over 3/4-inch

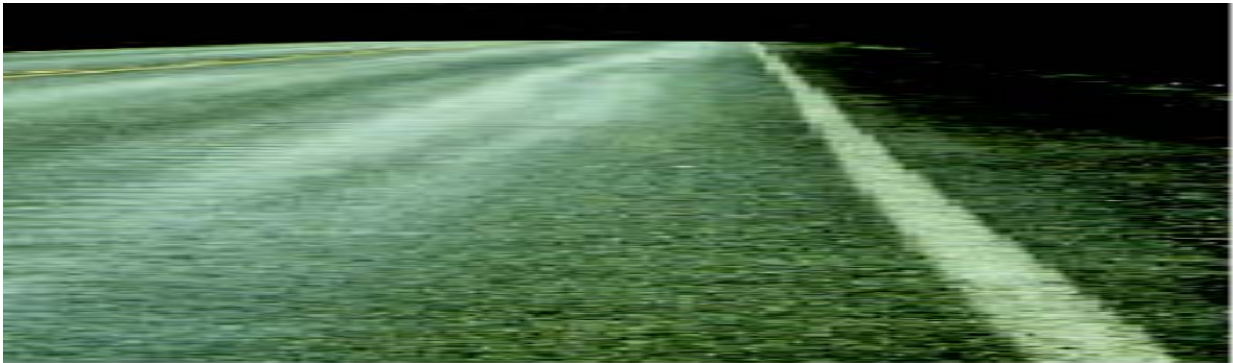
6. Corrugation-Rating Factor 0-5

This distress category covers a general form of surface distress which is not limited to the wheel path, although they may occur in the wheel path. The distress may occur in isolated areas, such as at intersections, or it may occur over a large part of the roadway surface. Corrugations/waves are regularly occurring transverse undulations in the pavement surface. Corrugations occur as closely spaced ripples, while waves are undulations whose distance from peak to valley is more than 3 feet.

Severity: The severity of corrugation is defined as the maximum vertical deviation from a 10-foot straightedge placed on the pavement parallel to the center line of the roadway.

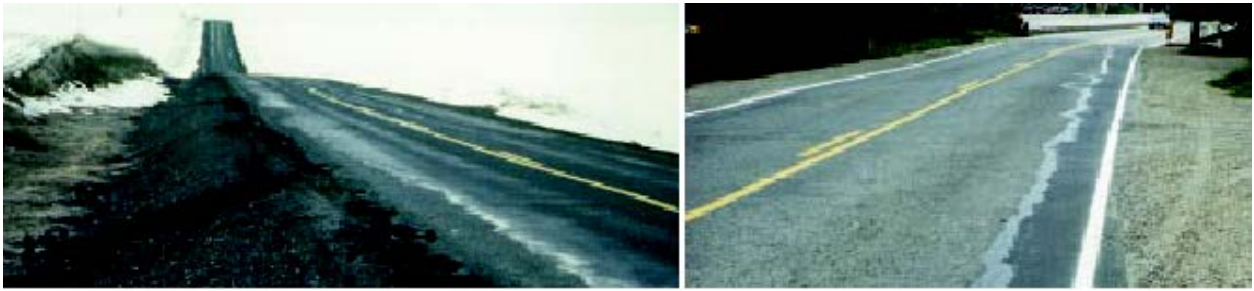
7. Raveling-Rating Factor 0-5

Edge raveling occurs when the pavement edge breaks away from roadways without curbs or paved shoulders. However, edge conditions can still occur with paved shoulders. Edge/base patching is the repair of this condition. The “lane less than 10 feet” distress indicates that the edge raveling has progressed to the point where the pavement width from the center line to the outer edge of roadway has been reduced to less than 10 feet or impacts the travel lane.

Measure: Accumulate the lengths along the surveyed lane of each type edge defect as it occurs. Divide the accumulated lengths by the length of the segment. Multiply by 100 to get percent, and round to a whole number.

Low — Edge Raveling
RATING VALUE=1-2

Medium — Edge Patching
RATING VALUE=3-4

High — Edge lane less than 10-12 feet
RATING VALUE=4-5

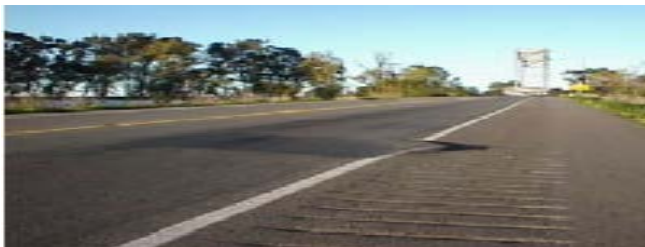
8. Shoving or Pushing-Rating Factor 0-10

Shoving or pushing is a lateral displacement of pavement material, and usually caused by vehicles consistent braking. Shoving or pushing further may occur in roadways where there is an insufficient road base, such as an aggregate, or binder. These segments will require a base repair, consisting of an excavation depth of a minimal of six to nine inches. A binder bituminous product is then used to stabilize the base and further capped with an inch and a half bituminous surface.

Low — 1/2-inch to 1-inch per 10-12 feet
RATING VALUE=1-3

Low-Medium — 1-inch to 2-inch per 10-12 feet
RATING VALUE=4-6

High — 2-inch and greater per 10-12 feet
RATING VALUE=7-10

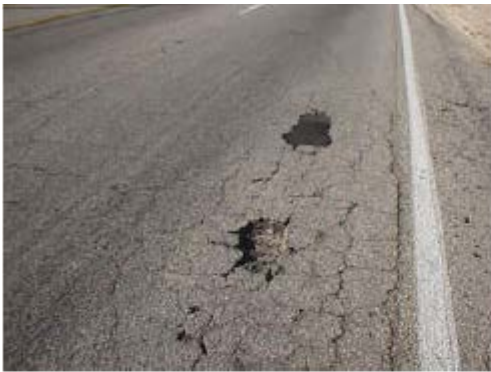
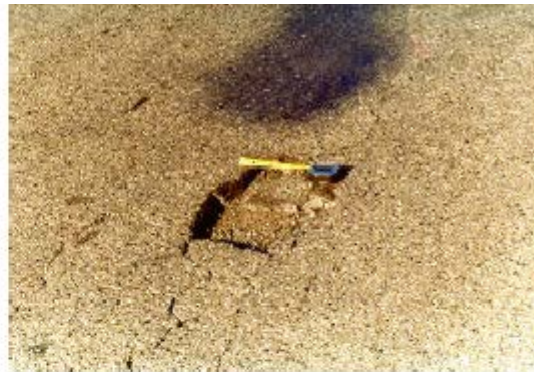
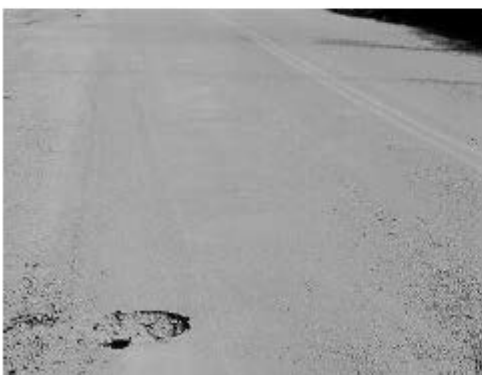
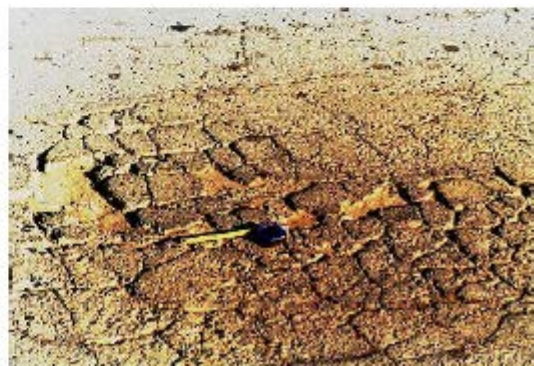
9. Pot Holes/Patches-Rating Factor 0-10

A patch is an area of pavement which has been replaced with new material to repair the existing pavement or access a utility. A patch is considered a defect no matter how well it is performing (a patched area or adjacent area usually does not perform as well as an original pavement section). A patch allows weathering to gain access around the weathering, in which if not sealed causes further deterioration of longitudinal cracking, and/or alligating. Generally, some roughness and smoothness is associated with this distress. In general, a patch is less than a typical rehabilitation in size and scope. They are less than full roadway width and/or are less than project length. Patches, or permanent repairs (dig-out repair), are included in this distress category. Utility cut patches are also included as part of the patching values. A patch regardless of its size is rated under the City of Darien current criteria.

While appropriately done repairs are an asset rather than a liability to the life of a segment of pavement, the fact that they were required (other than for utility work) generally indicates some failure in the pavement structure.

Severity: the average of potholes filled and or repair patches (base repairs) completed. These patches exclude utility work.

Low — 2 Potholes or 2 Base Repair Patches

Low-Medium — 3-5 Potholes 3-5 Base Repair Patches
RATING VALUE=3-4

Medium-High — 5-7 Potholes 5-7 Base Repair Patches or travel lane base repair up to 50 feet by 12 feet.
RATING VALUE=5-7

High — 8 or greater Potholes 8 or greater Base Repair Patches/or travel lane base repair in excess of 50 feet by 12 feet.
RATING VALUE=8-10

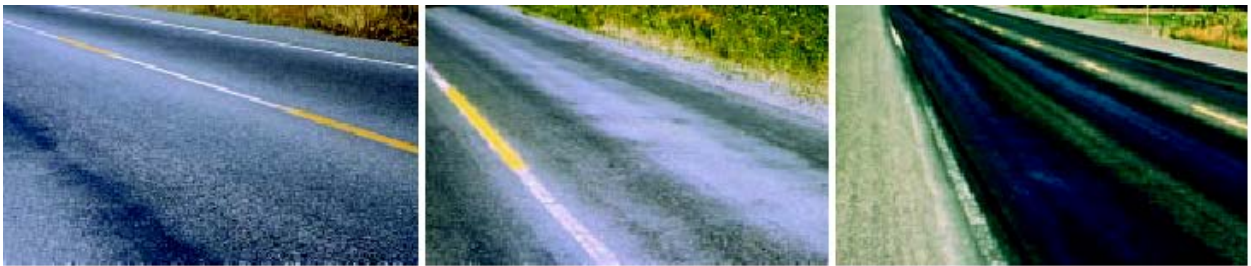
10. Excess Asphalt-Rating Factor 0-10

Flushing and bleeding is indicated by an excess of bituminous material on the pavement surface, which presents a shiny, glass-like reflective surface that may become sticky in hot temperatures. At the lower severity levels, the extents “localized” and “wheel path” may be difficult to differentiate; however, as the severity increases, “wheel path” becomes better defined. Wheel path refers to tire tracking area and may be used to represent the condition of only one wheel track being heavily involved. This distress is measured or observed through the loss of aggregate (raveling), commonly referred to as “chip loss”, and leaves the binder exposed.

Low — Minor amounts of the aggregate have been covered by excess asphalt but the condition has not progressed significantly.
RATING VALUE=1-2

Low-Medium — Moderate quantities of the surface aggregate have been covered with excessive asphalt. Small amount of the coarse surface aggregate is exposed, even in those areas showing flushing.
RATING VALUE=3-4

Medium-high — Significant quantities of the surface aggregate have been covered with excessive asphalt. However, much of the coarse surface aggregate is exposed, even in those areas showing flushing.
RATING VALUE=5-7

High — Most of the aggregate is covered by excessive asphalt in the affected area. The area appears wet and is sticky in hot weather.
RATING VALUE=8-10
